Vince Bayou August 31, 2017 Aerial Photograph Expert Interpretation

Randall Grip
Aero-Data Corporation
9/27/2017

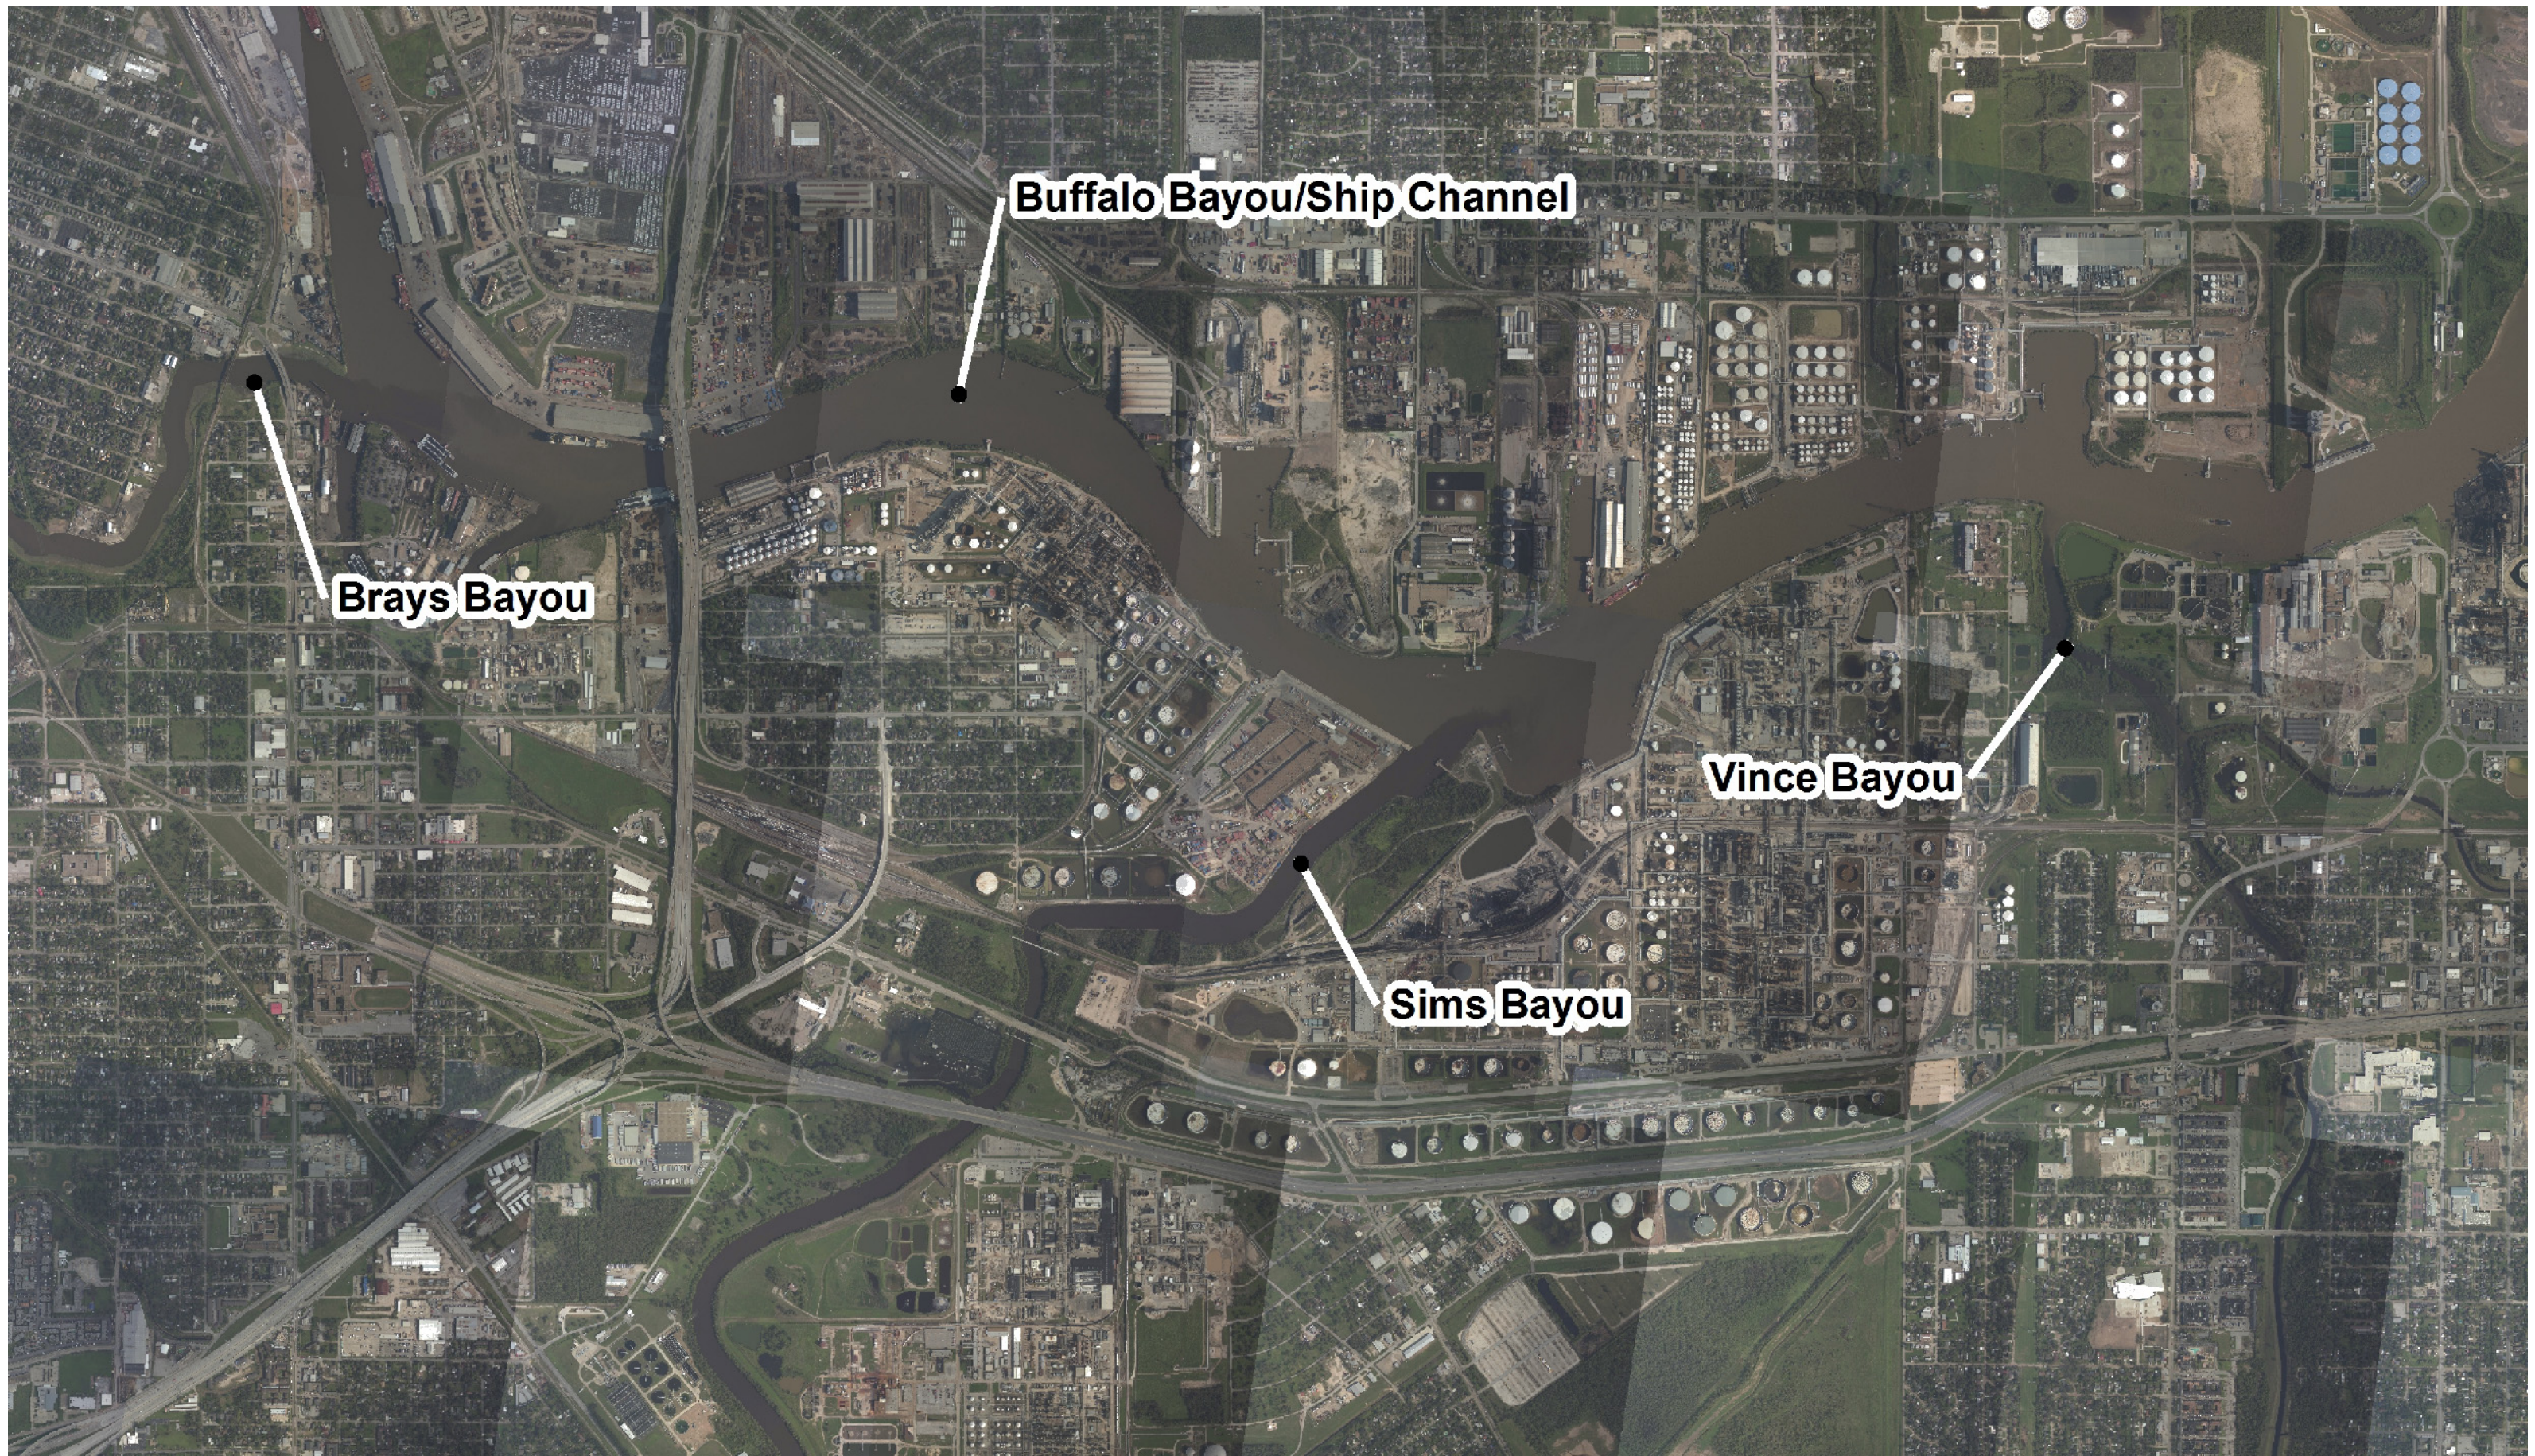
FIGURE 3

In addition, I have also reviewed a USGS map of the area (Figure 2), the 9/15/2008 imagery (Figure 3) from the NOAA which was taken after Hurricane Ike and the 10/22/2016 imagery (Figure 4) from USDA.

9/15/2008
Pasadena, TX
Photo Source: NOAA

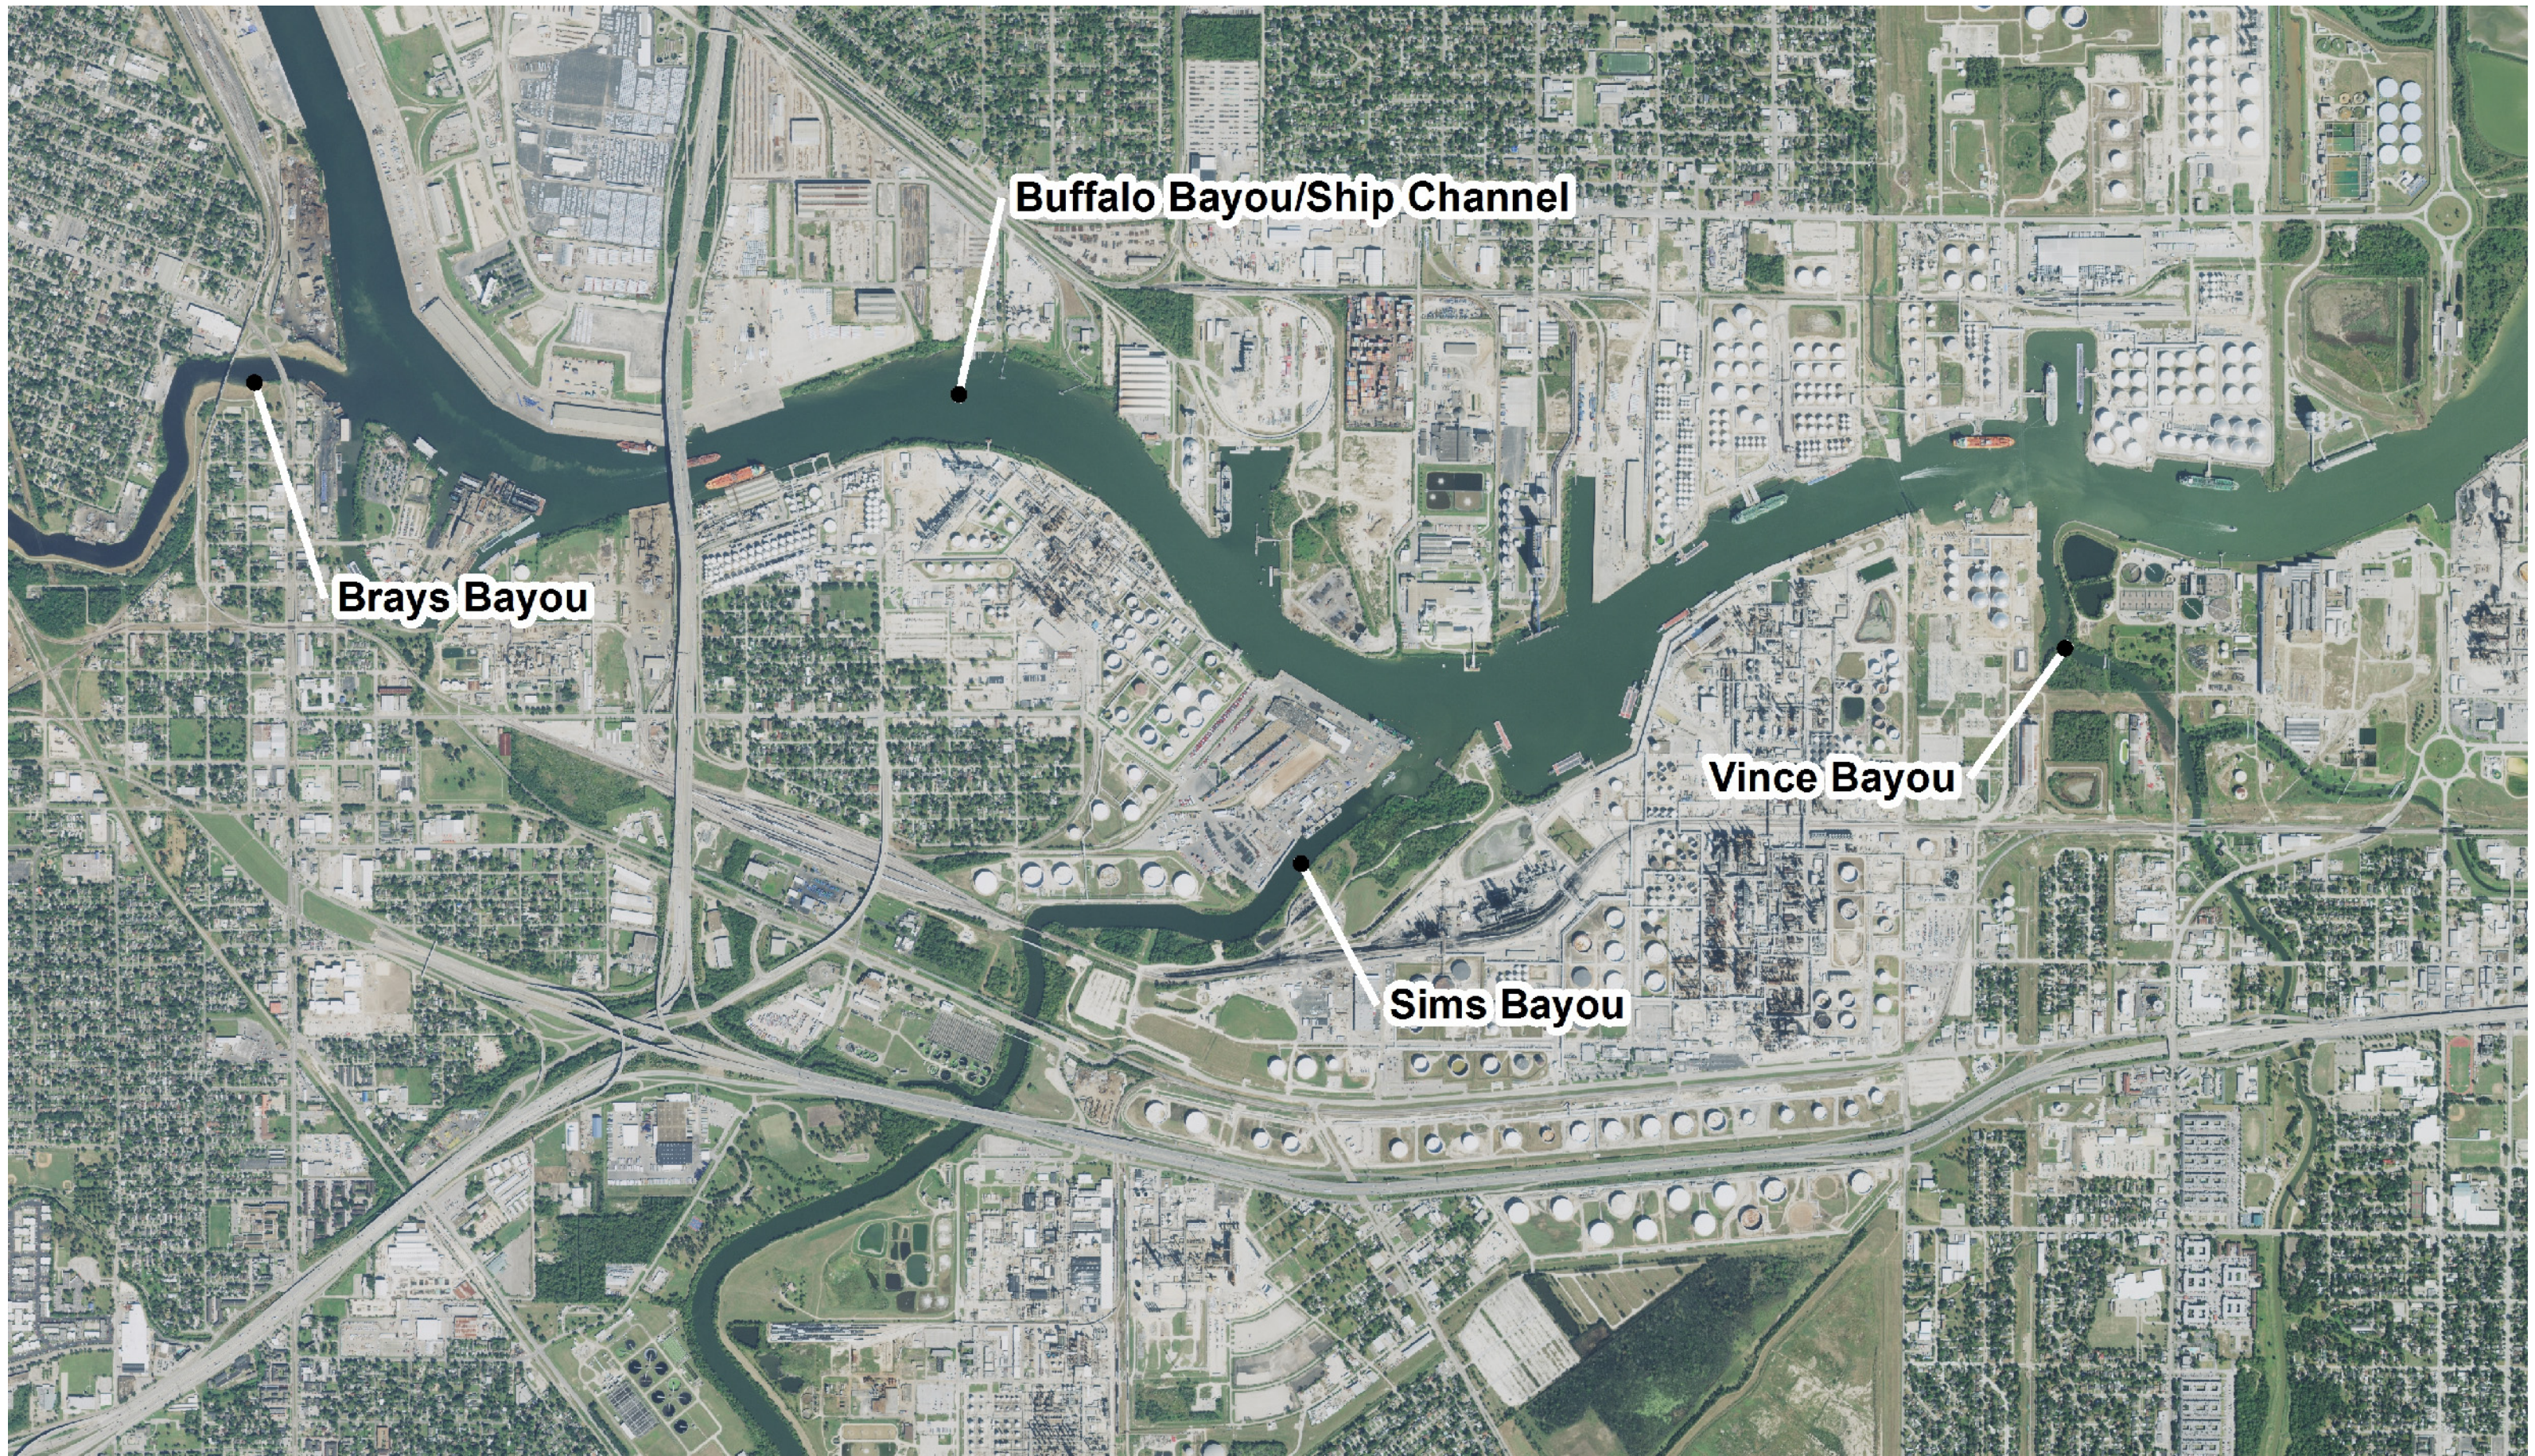
FIGURE 4

10/22/2016
Pasadena, TX
Photo Source: USDA-NAIP

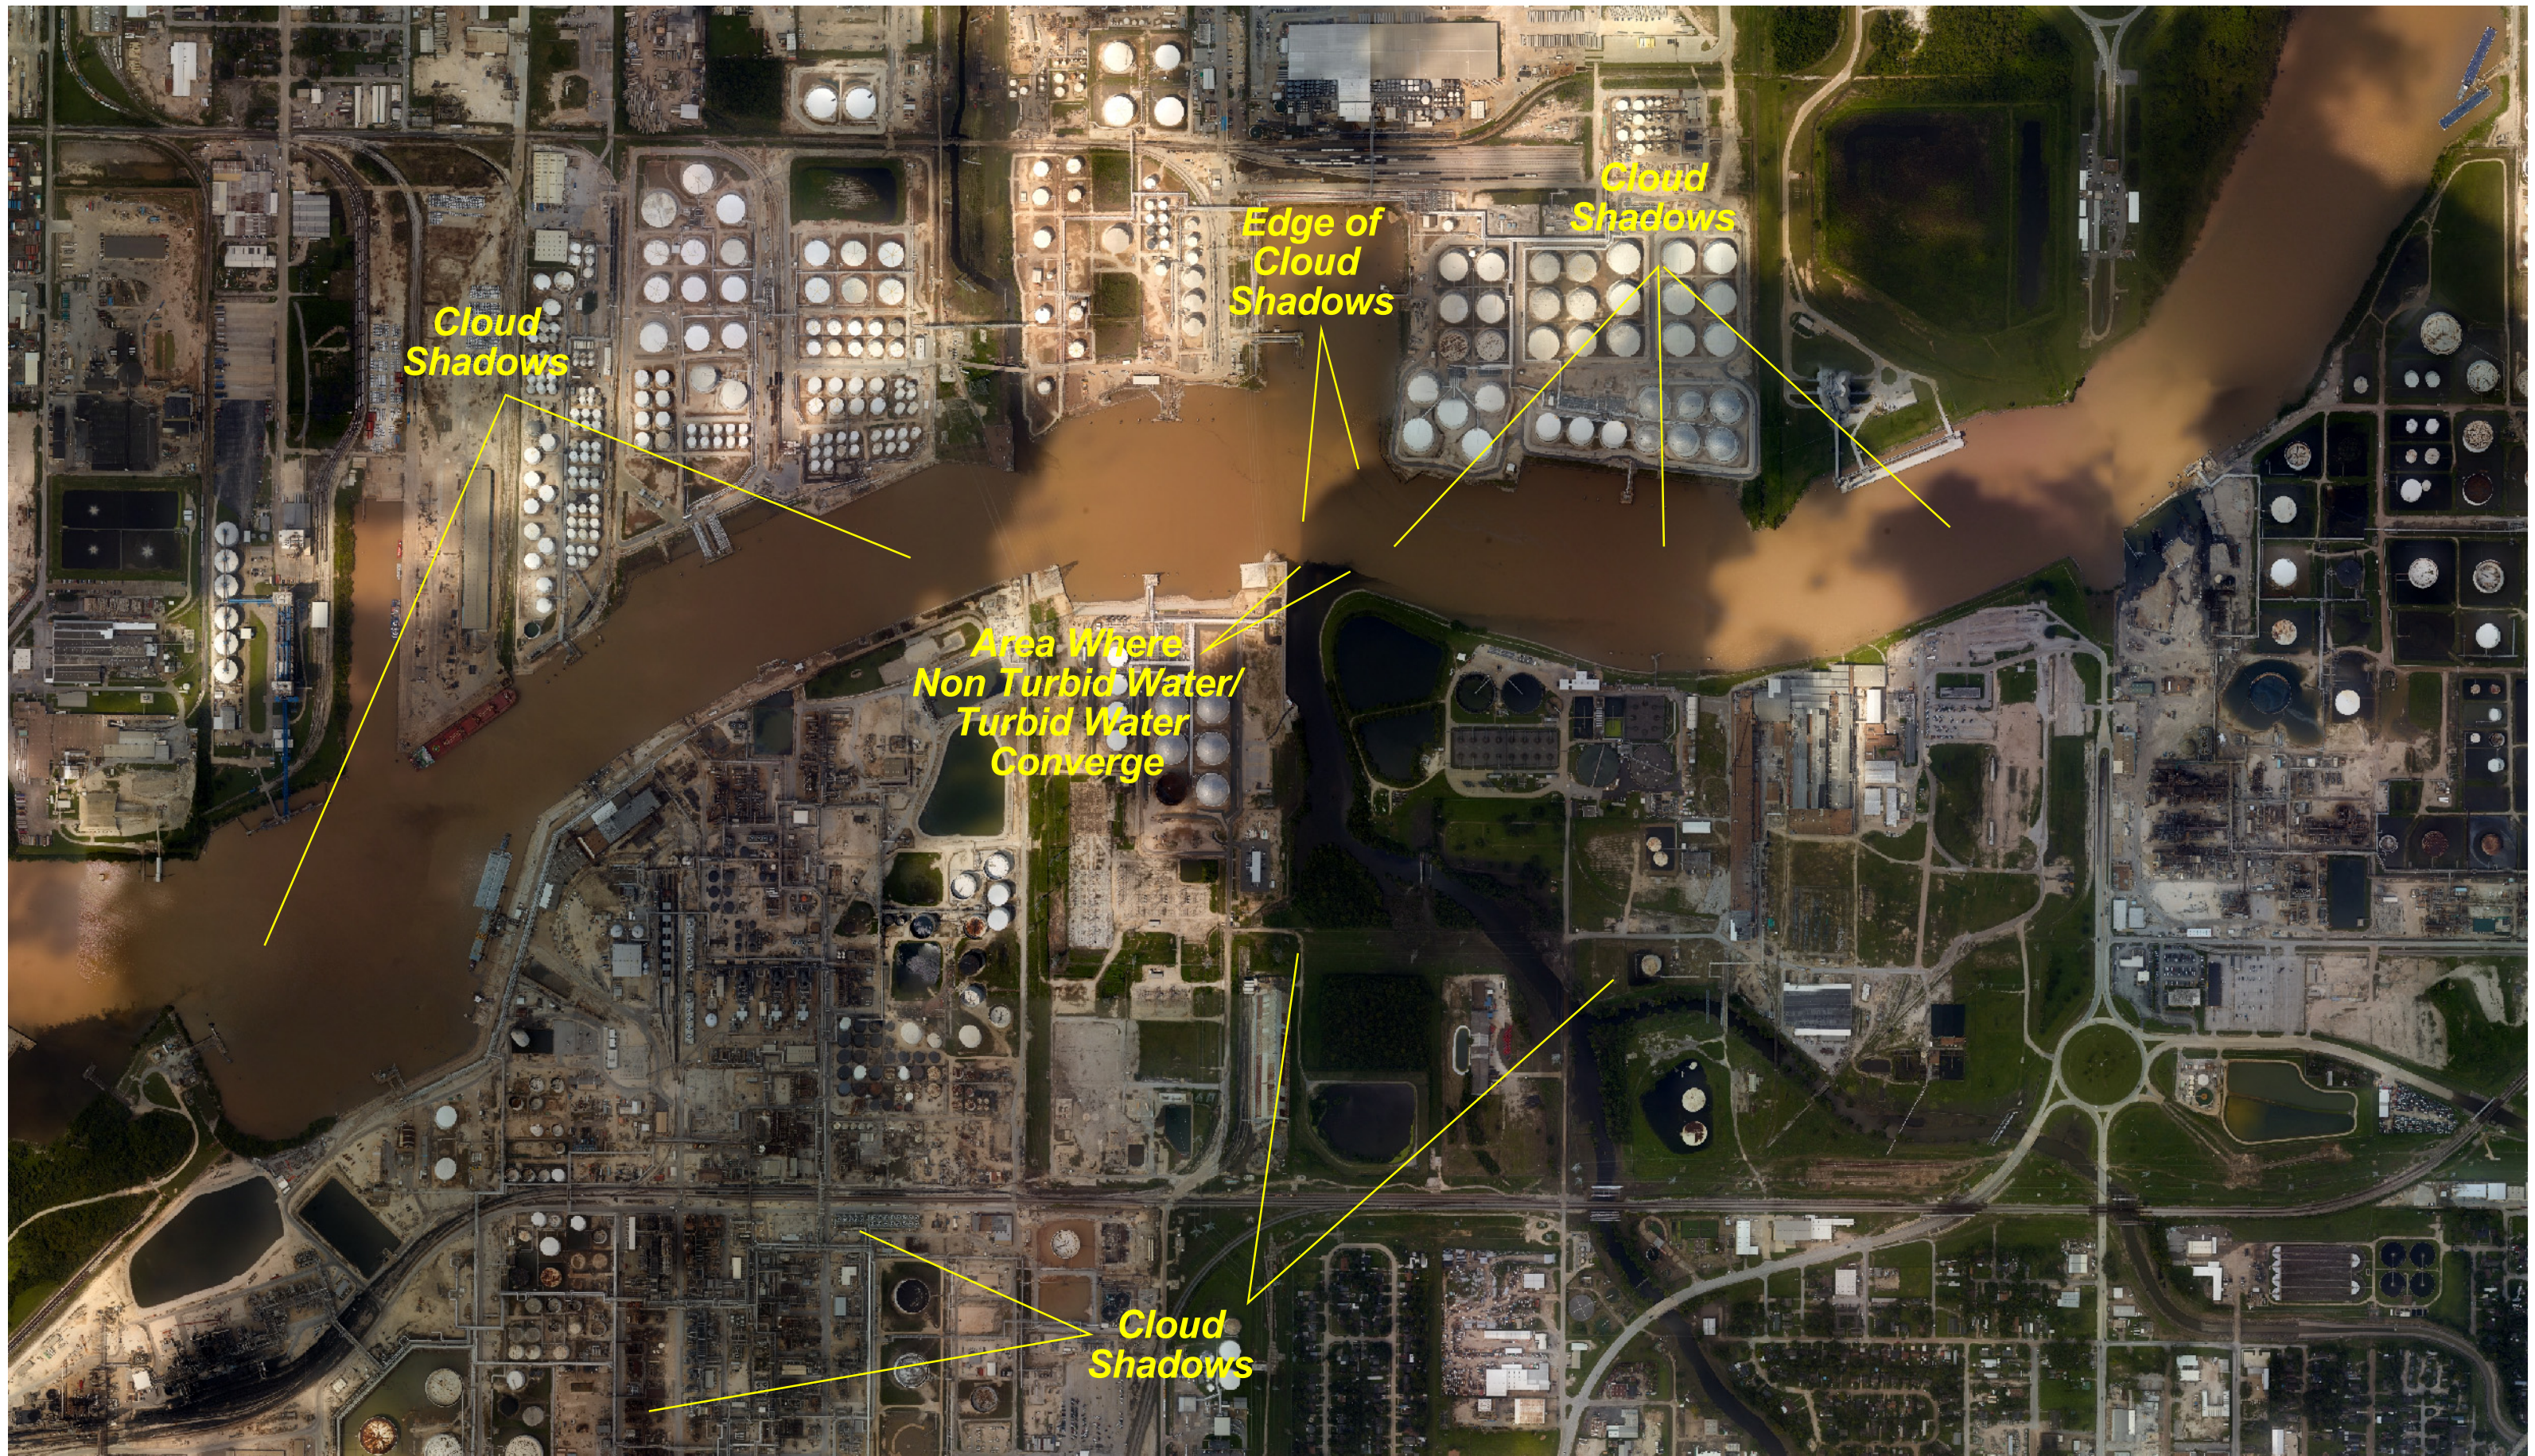
FIGURE 5

Dark-colored water is not necessarily indicative of contamination. In this case, Vince Bayou flowing into the ship channel is not evidence of contamination transport. The water within the ship channel is turbid, likely due to the sediment from the receding floodwaters. The water flowing from Vince Bayou is not as turbid and therefore, appears darker. Also the location of the confluence of Vince Bayou and the Houston Ship Channel is within a cloud shadow on the 8/31/2017 aerial imagery which makes the area appear even darker. (Figure 5)

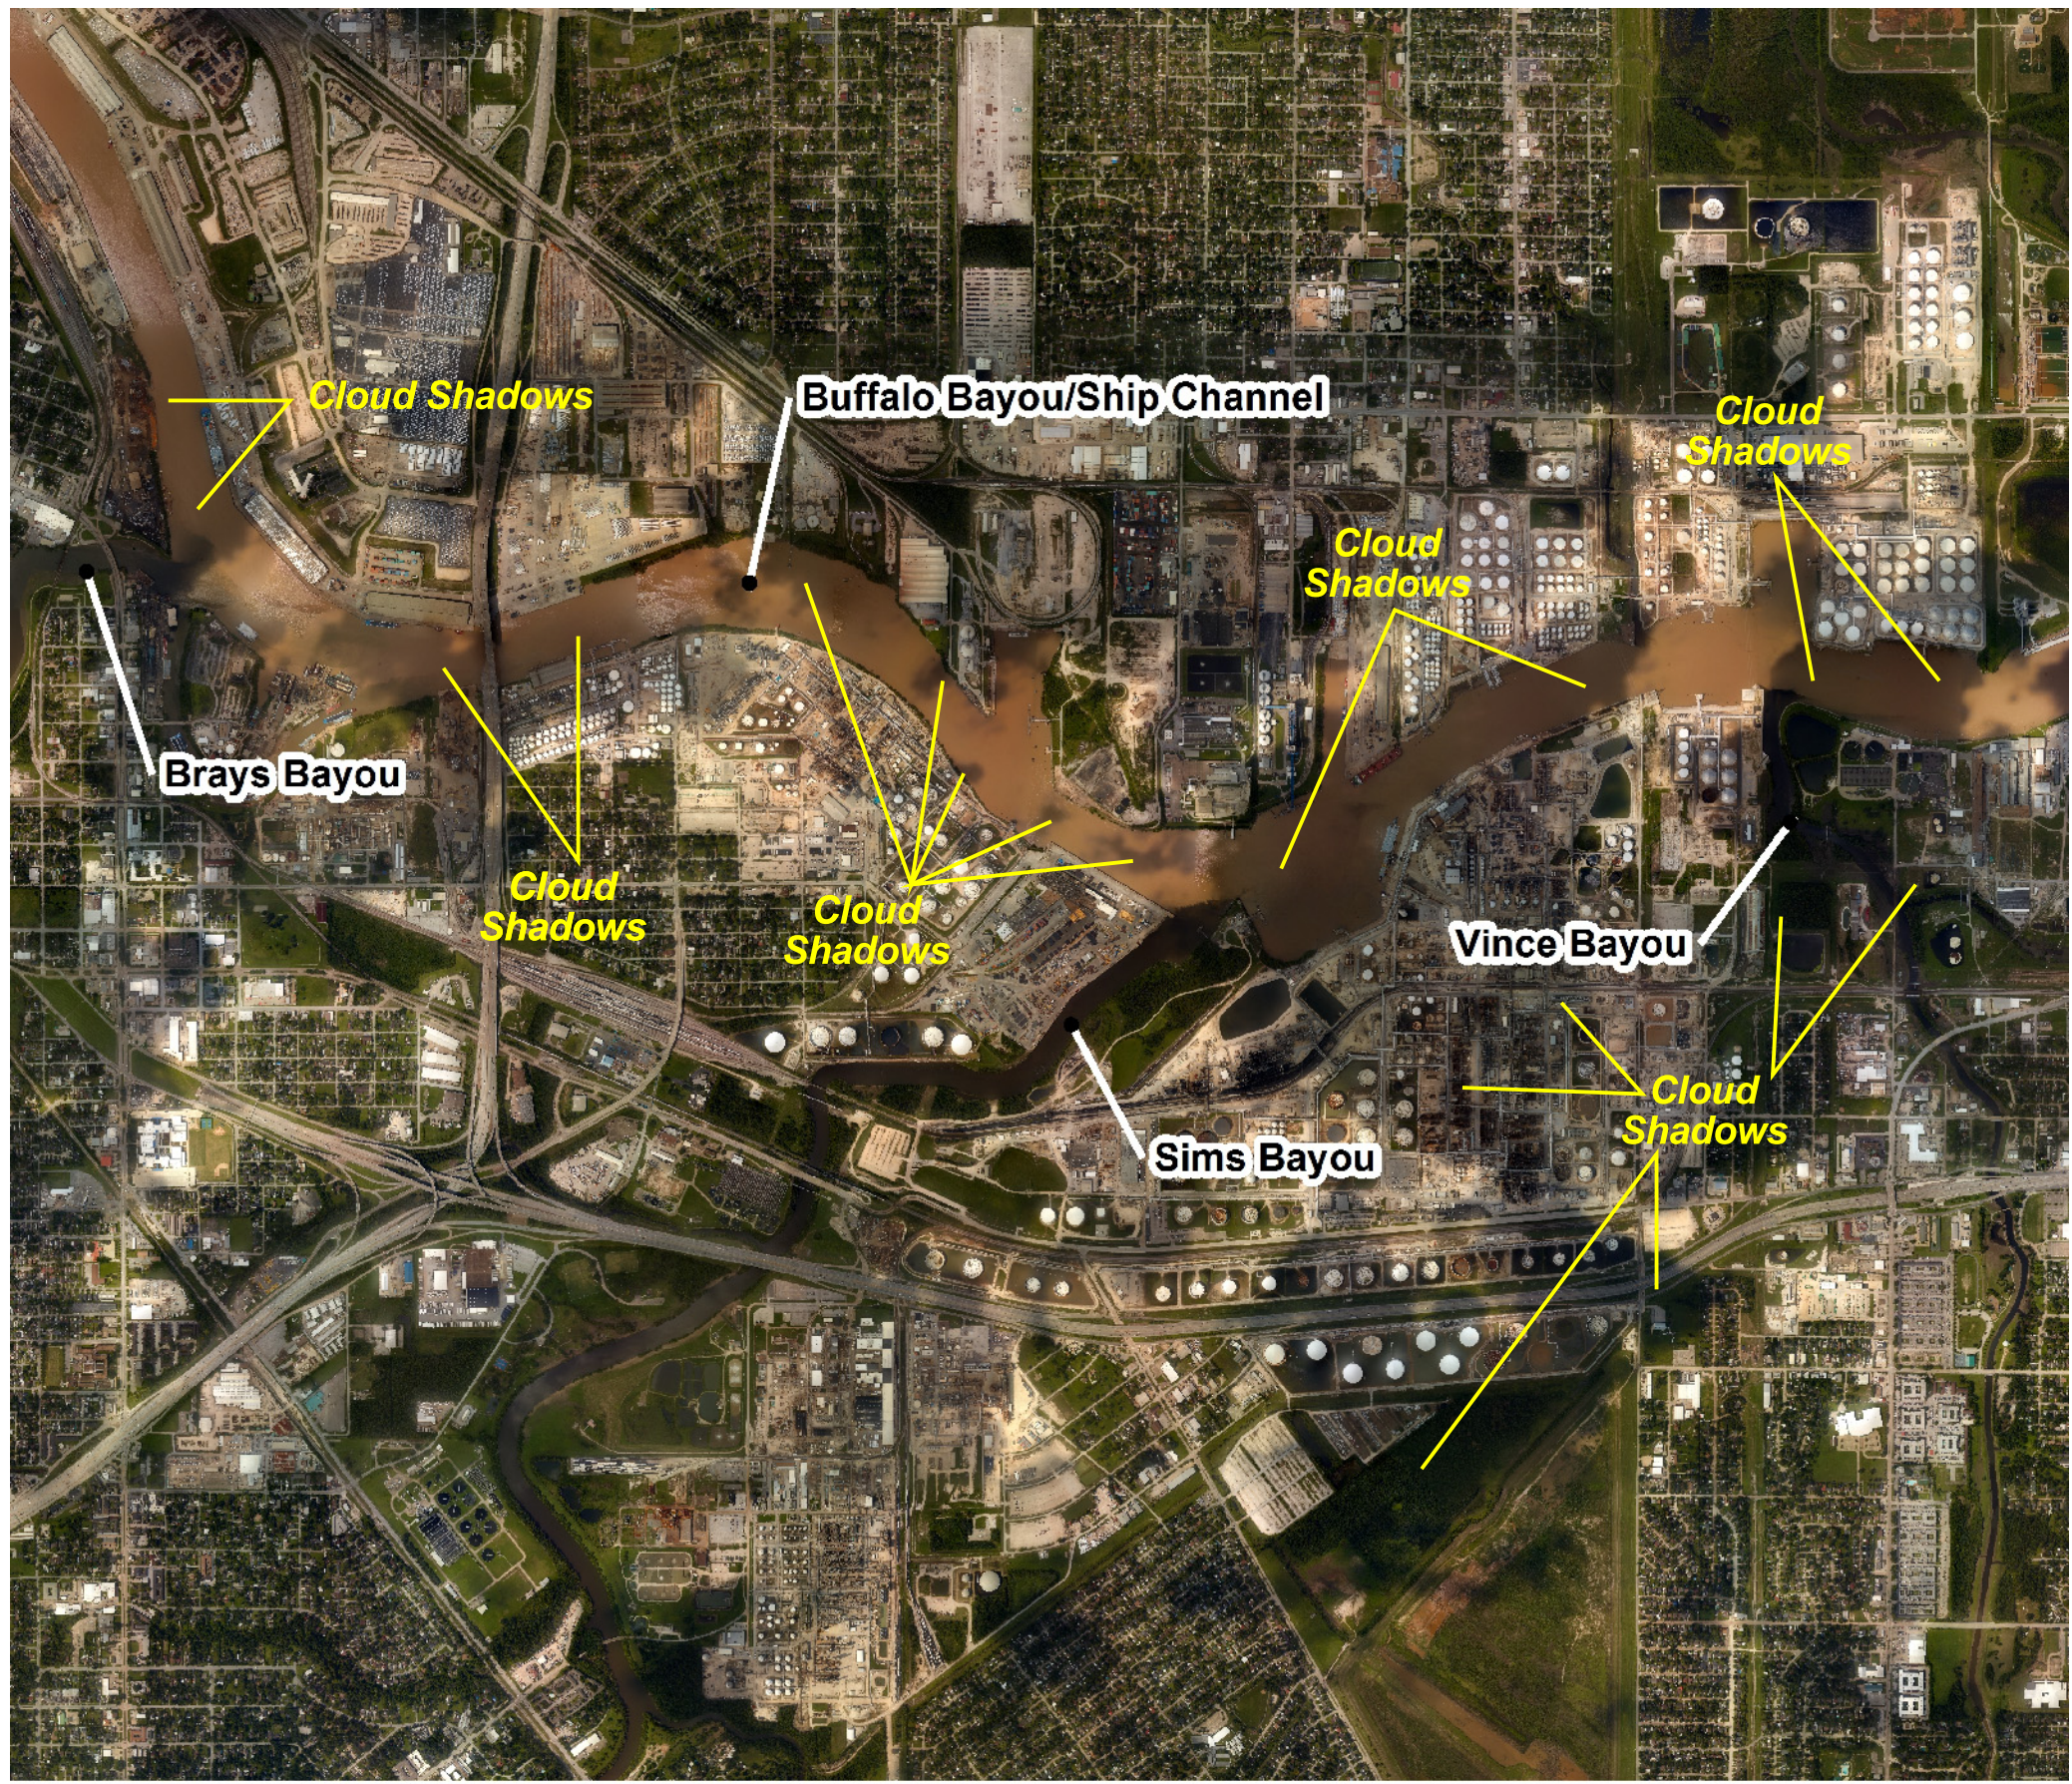
FIGURE 6

The same dark-colored water signature is visible on several other bayous in the area. Sim's Bayou and Bray's Bayou also have a darker color due to turbidity variations in the bayous and streams compared to the ship channel. Also, cloud shadows are notable throughout the 8/31/2017 imagery. (Figure 6)

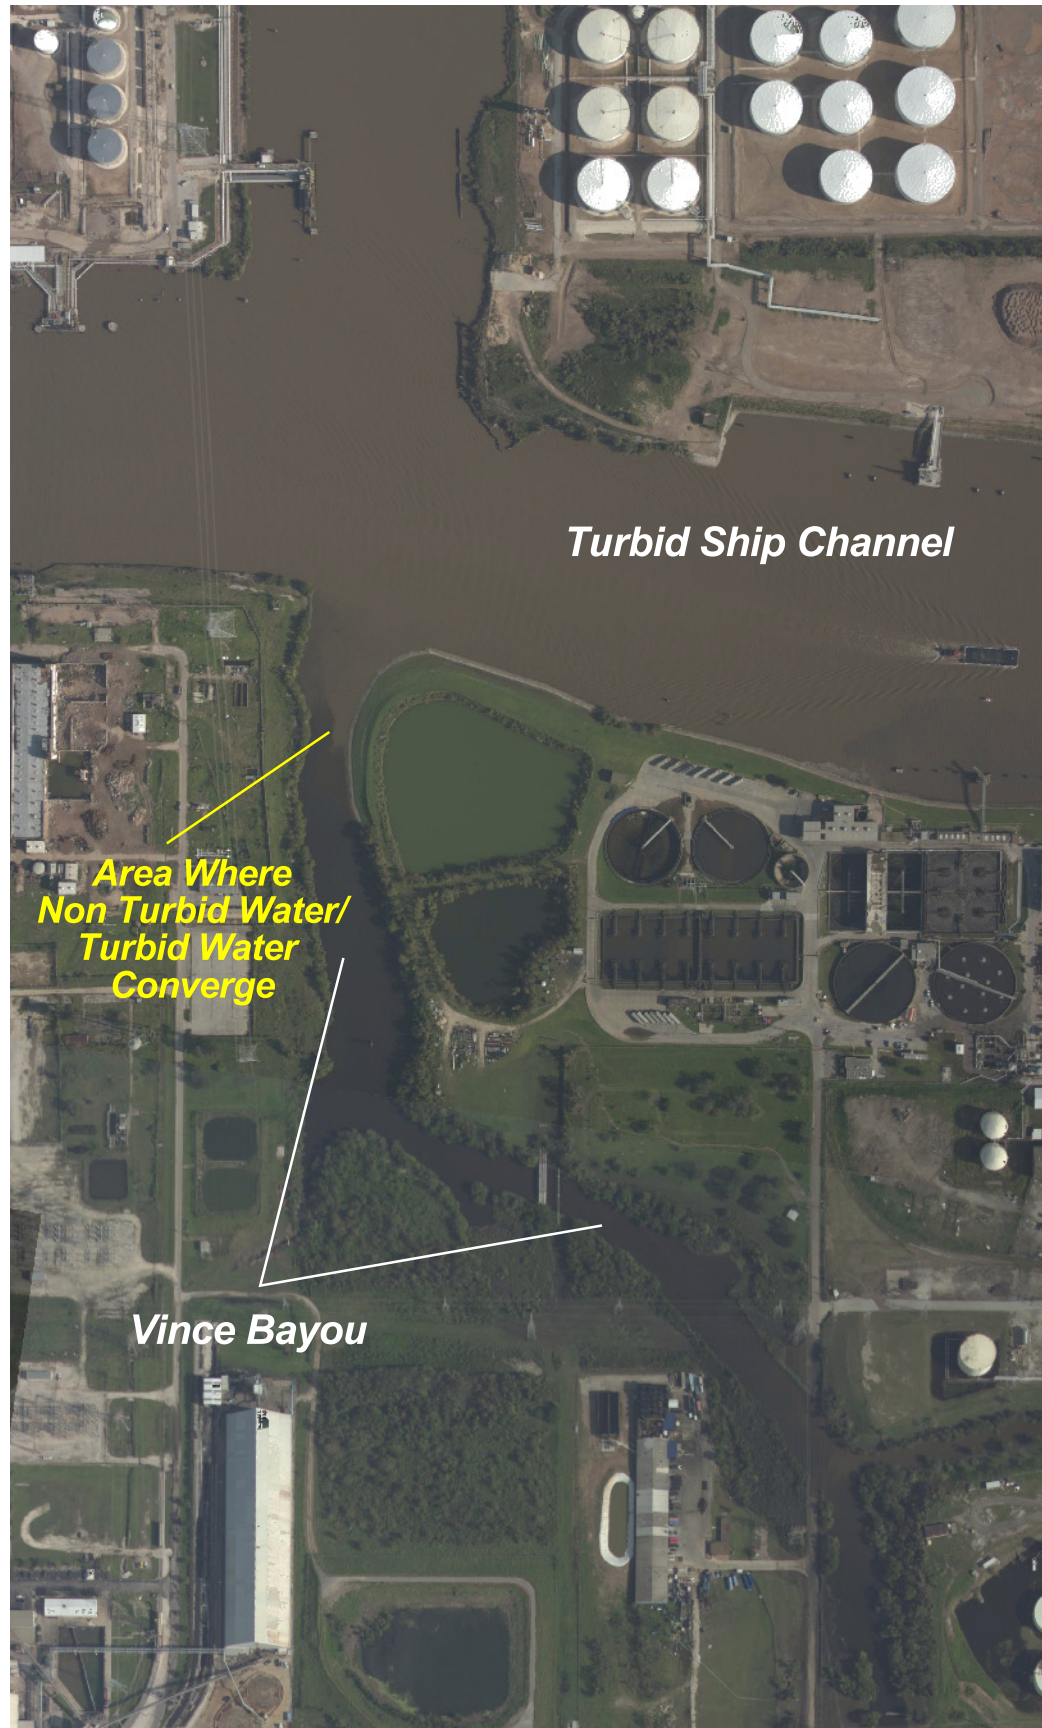
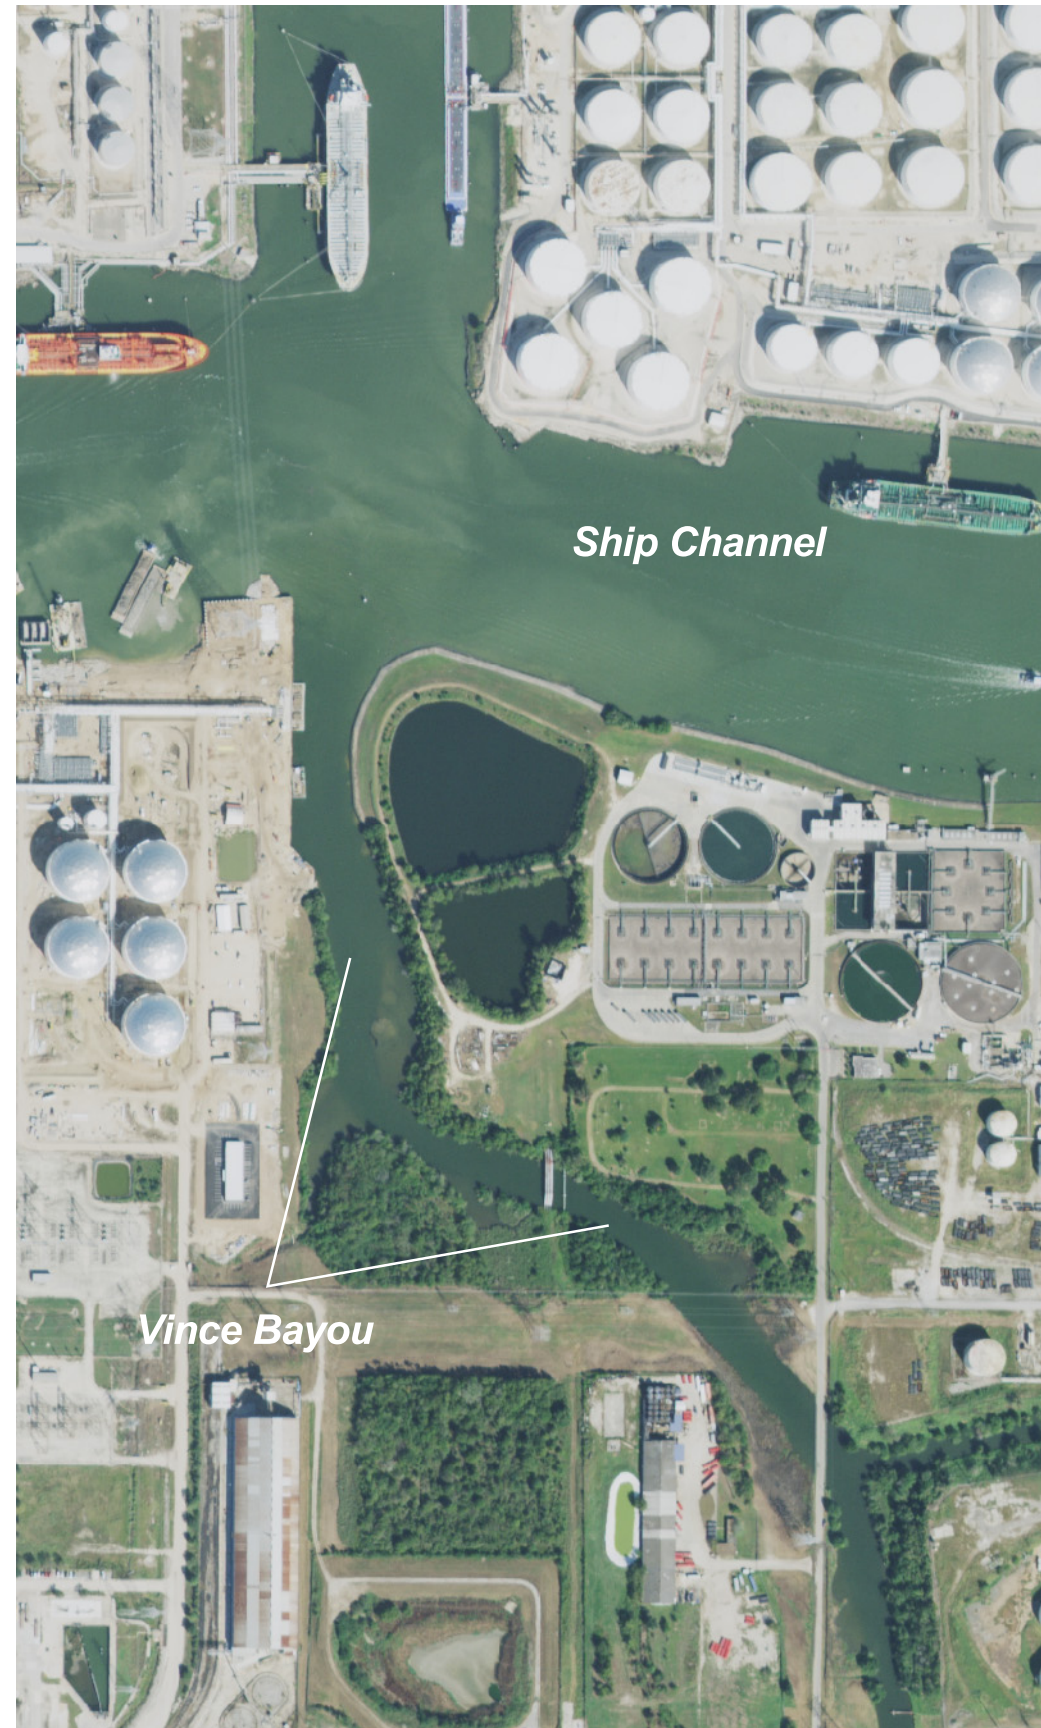
FIGURE 8

The 9/15/2008 imagery from Hurricane Ike was also reviewed and shows the same pattern of less turbid water flowing from the bayous into a more turbid ship channel. An image has been created to show the Hurricane Ike 9/15/2008 imagery, the 10/22/2016 USDA NAIP imagery (non-storm imagery) and Hurricane Harvey 8/31/2017 imagery. (Figure 8)

Confluence of Vince Bayou and
Buffalo Bayou/Houston Ship Channel
